AmeriSpec Inspection Service

Doc #: 17124871 Inspector: Jason Fraser

Date: 12/11/2017

Dwelling Address: 85 Basinview Dr.
Bedford, NS

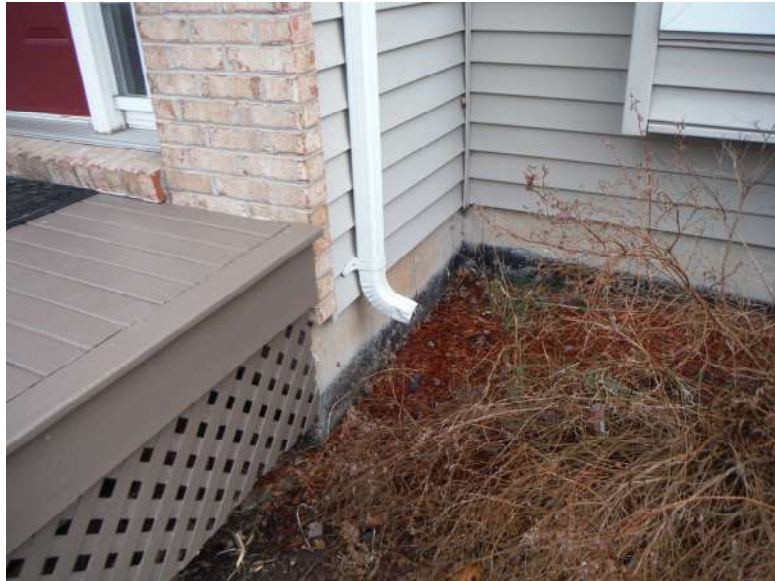
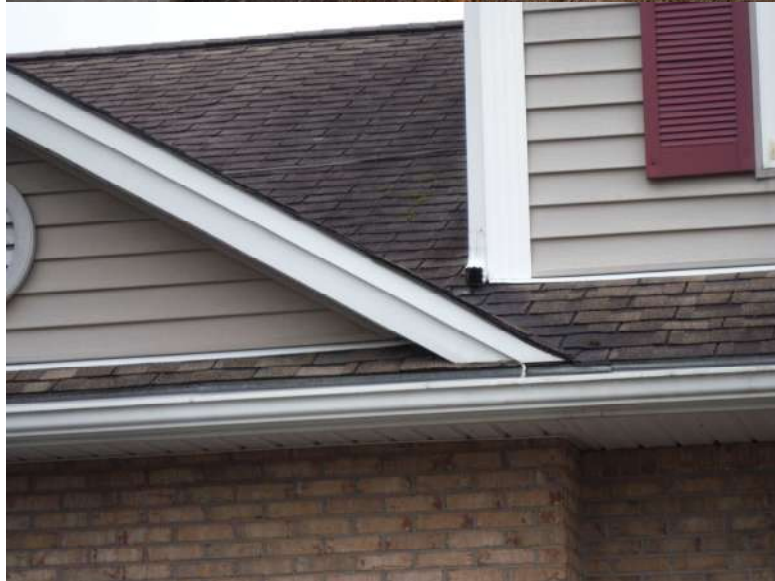
1107. Gutters / Downspouts Review. Aluminum. Suggest installing extensions to gutter system to ensure proper drainage away from foundation in order to ensure proper drainage. The client is advised to have the upper downspouts extended down into the gutter in order to prevent premature deterioration of the roof shingles as potentially result in leakage

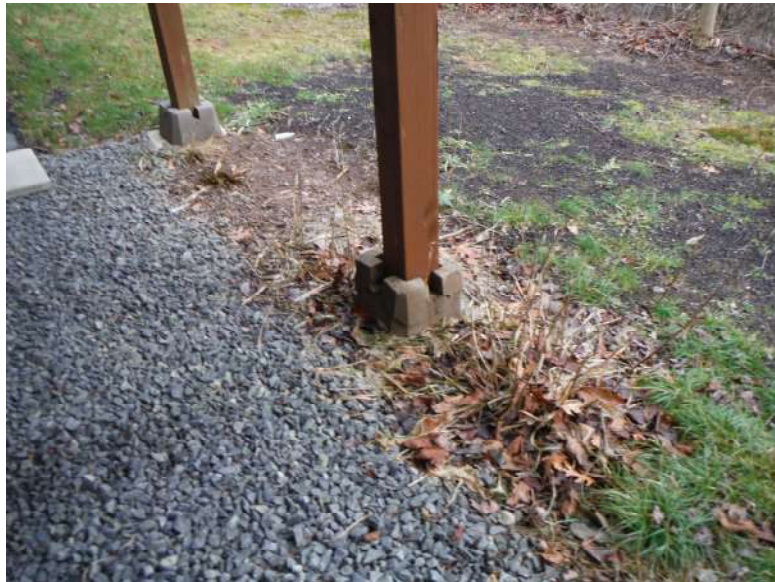
1119. Deck Support Review. As with most structures built on top of the ground, a certain amount of settling/heaving occurs seasonally with frost action. If concerned the client is advised to re-level this deck. The support posts were sitting on deck blocks, one of which was cracked. Ideally support posts would be sitting on poured concrete footers. This was a common installation practice when this deck was constructed. Deck blocks can result in heaving and settling over time.

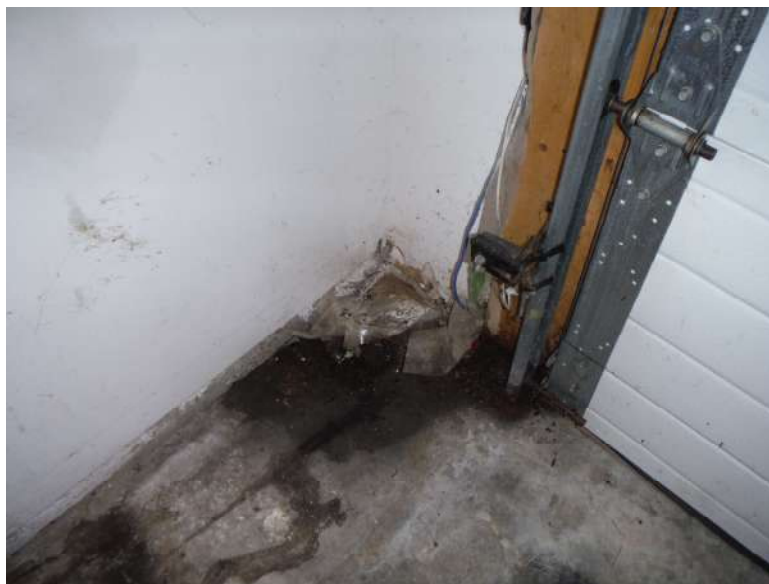
Step #	Component	Comment
1301.	Type	Attached garages in most jurisdictions should be separated from common walls of the house by a proper fume rated wall and fume gasketed door with a self closer. This is to keep the migration of any smoke or fire from entering the house in the event of a fire in the garage. It also reduces the risk of any products of vehicle combustion from entering the home.
1302.	Exterior	Garage is attached to house. See exterior section of the inspection report for further information.
1303.	Methods Used To Inspect Roof	Attached. See the roof section of the inspection report for additional information.
1304.	Roof Material/Type	Same as house roof material in step #1202.
1305.	Roof Conditions	See roof conditions # 1205.
1306.	Gutters / Downspouts	See exterior comments # 1107.
1307.	Floor/Slab	Review. Concrete. Moisture noted at front right corner of garage. Inspector was unable to determine if moisture is due to water infiltration or was from items stored in garage. Recommend review by qualified contractor.

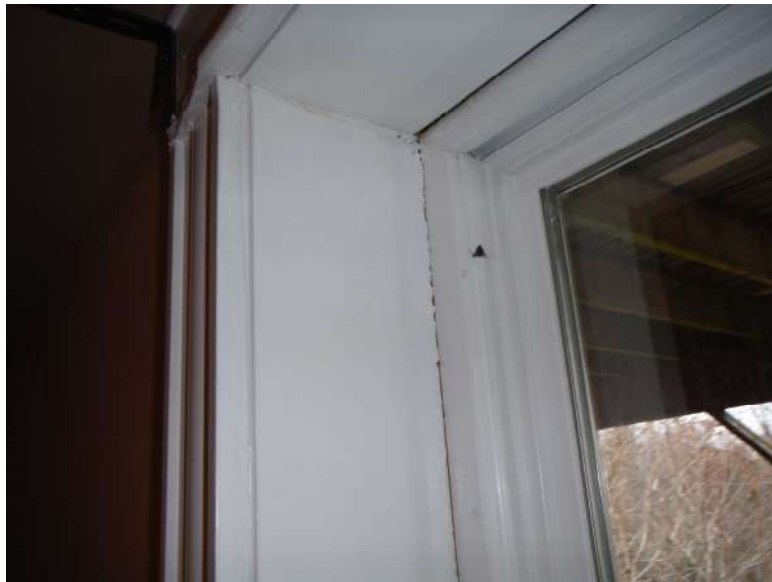
Step #	Component	Comment
1601.	Access	Finished areas in basement were observed. As the building materials are not visible due to finishing work, only visible components at the time of inspection were reviewed.
1602.	Stairs	Wood.
1603.	Floor	Concrete; Carpet; Ceramic tile.
1604.	Walls	Drywall.
1605.	Ceiling	Drywall.
1606.	Exterior Door(s)	Metal.
1610.	Support Posts / Columns	Wood.
1611.	Beams	Wood.
1612.	Windows	Review. Evidence of past leakage at rear basement window under deck. Inspector checked area with a moisture meter and did not find elevated moisture levels. Inspector is not able to determine cause of the leakage without destructive analysis. Recommend further review by qualified contractor.

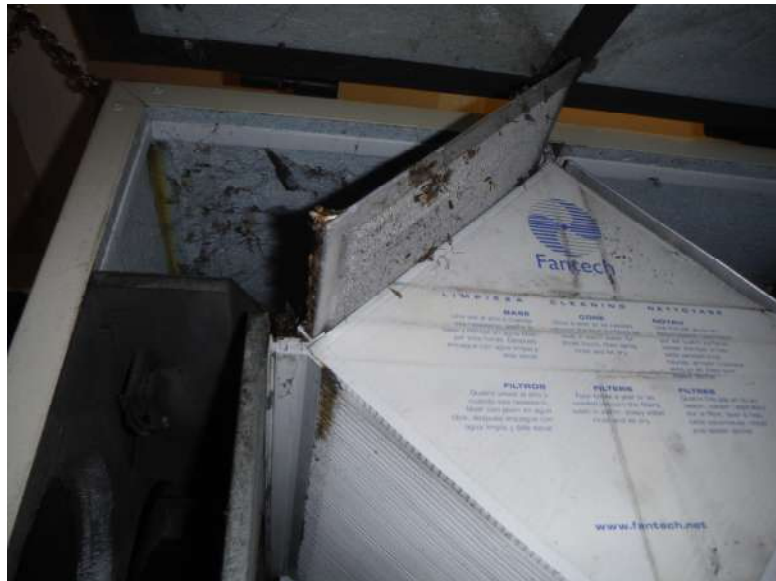
Step #	Component	Comment
1921.	HRV	<p>Review. A heat recovery Ventilator was noted in the house. The client is advised that only a cursory review of appliances is performed as a structural home inspection. HRV systems may have multiple motors and other moving components. The client is advised to consult with the vendor regarding any instructions or warranties applicable. The client is also advised to operate this system at the final walk through inspection to ensure that it is still serviceable. If a more detailed inspection is required, consultation with a qualified HVAC technician is advised. The exterior Heat Recovery Ventilator air intake vent was dirty/covered with debris at the time of inspection. Suggest cleaning the vent in order to promote adequate air flow to the HRV appliance. The client is advised to have the internal filters and core cleaned and the system serviced as the components were dirty at the time of inspection.</p>
